Applies To: **See VEHICLES AFFECTED****June 7, 2005****Child Seat Anchor Locating Button Is Missing****(Supersedes 05-016, dated May 12, 2005, to update the information marked with the black bar)****PROBLEM**

The small button on the rear seat-back cover that marks the location of each child seat LATCH lower anchor is missing.

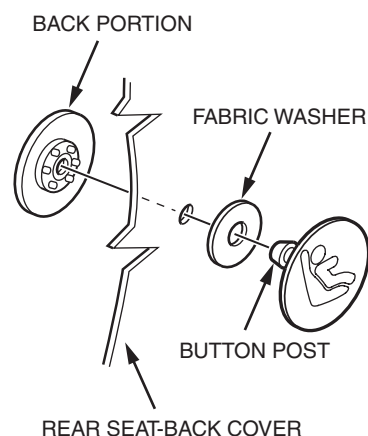
1. Remove the rear seat-back cover just enough to allow access to the opening where the button will be attached:
 - Refer to Section 20, Rear Seat-back Cover Replacement, in the appropriate service manual, or
 - Online, enter keyword **SEAT COVER**, and select the appropriate **Rear Seat-back Cover Replacement** procedure from the list.
2. Select the appropriate button from the Child Seat Anchor Service Set.
3. Attach the button to the rear seat-back cover:
 - Place a fabric washer over the button post.
 - Insert the post through the opening in the cover.
 - Snap the back portion onto the post.

4. Repeat steps 2 and 3 as needed for additional buttons.
5. Install the seat-back cover in the reverse order of removal.
